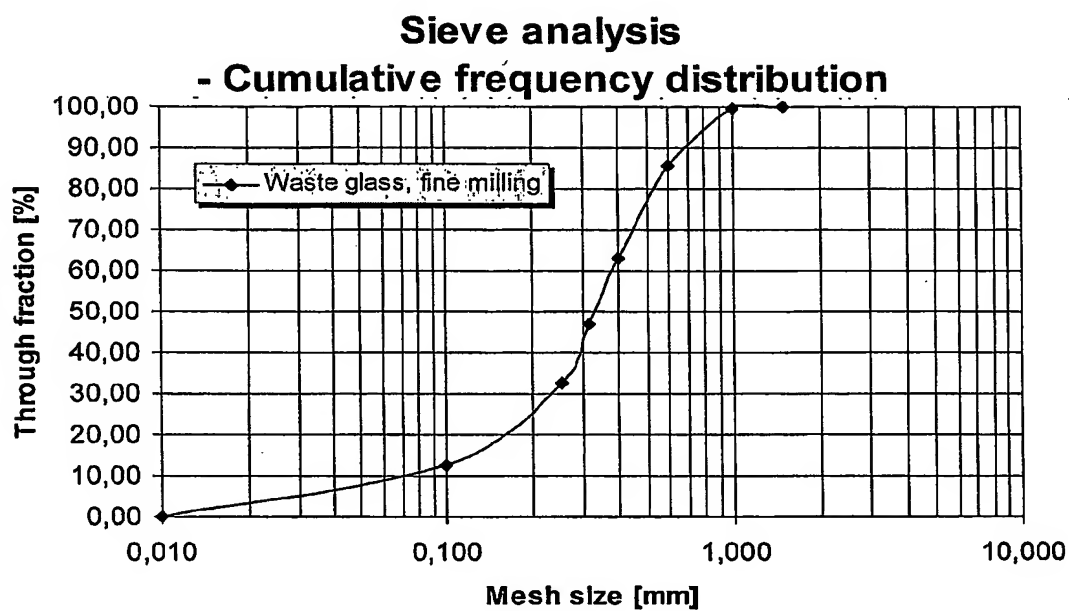
Fig. 1: Result of a sieve analysis of the charged ground waste glass granulate
